River Ems Investigation

Flow Augmentation Monitoring Trial

Portsmouth Water

5204159-08-091

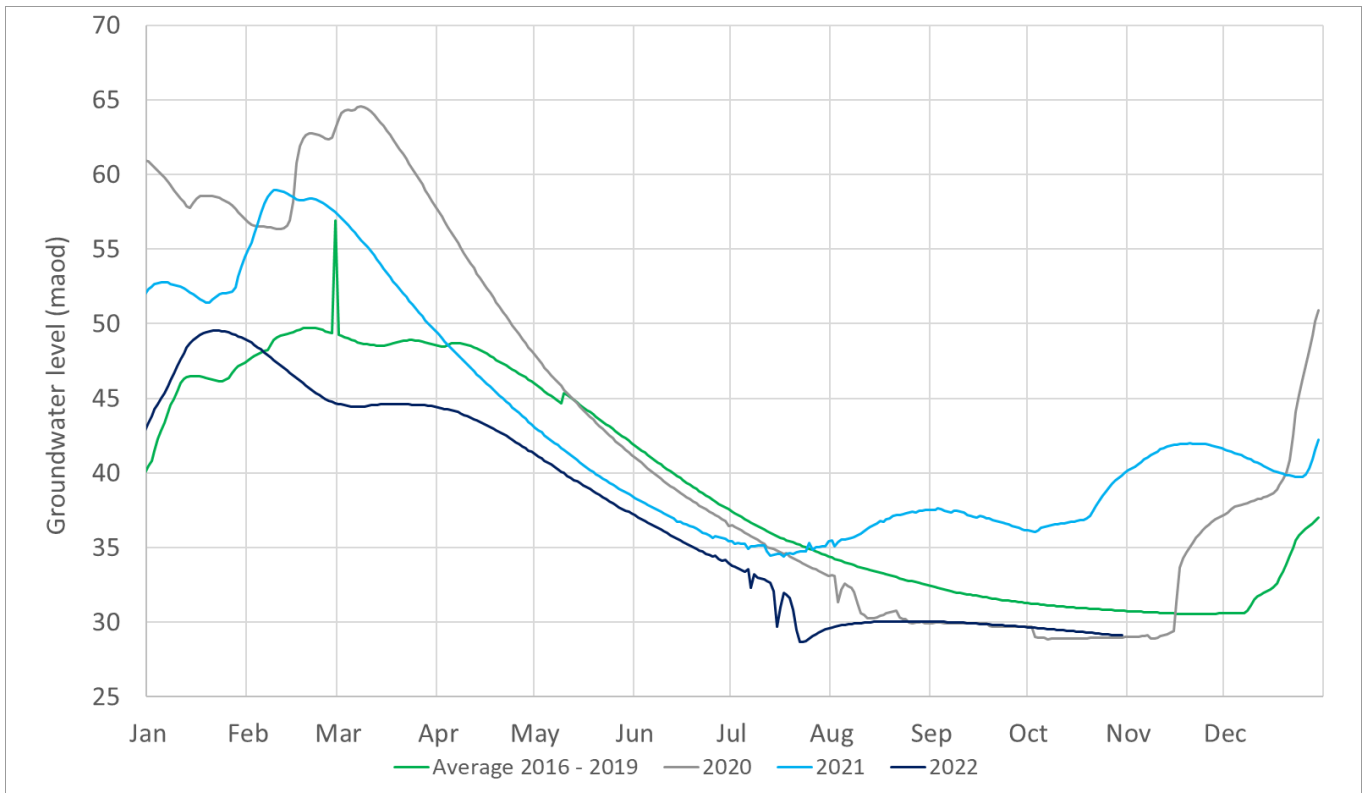
Figure 3-5 – Groundwater levels at Compton Well

Compton Well is located within the Ems catchment, approximately 5 km north of augmented reach and holds one of the longest groundwater records in the Chalk. Figure 3-5 presents groundwater levels at Compton Well from 2020-2022 and average groundwater level from 2016 to 2019.

Figure 3-5 shows that in general levels at Compton are lower than in previous years, particularly in early 2022 when there should be the typical seasonal groundwater high. The 2022 record shows an overall decline in groundwater level from late January onwards. It should be noted that the data recorded over the summer period (July onwards) are currently under review by the Environment Agency due to apparent issues with the data logger⁷. The record appears to show a sudden and out of character change in the groundwater record during a period of stable and sustained dry conditions. Although there are questions surrounding the reliability of the logger during the summer, the record shows 2022 to have lower groundwater levels in comparison to previous years. This is not surprising given the rainfall record summarised in section 3.2 but reiterates the low volume of water within the catchment due to regional drought conditions.

January to April is much lower in comparison to other years. This aligns with the groundwater levels seen at Compton OBH in early 2022 (Figure 3-5) and reflects the low rainfall and decreased volume of water in the catchment. The receding limb of the hydrograph from May 2022 onwards appears to show a similar rate of decline to 2021 however due to the lower amount of water in the river to start with, flows in 2022 reached the augmentation trigger earlier than in previous years (for example, 2-3 weeks earlier than in 2020).

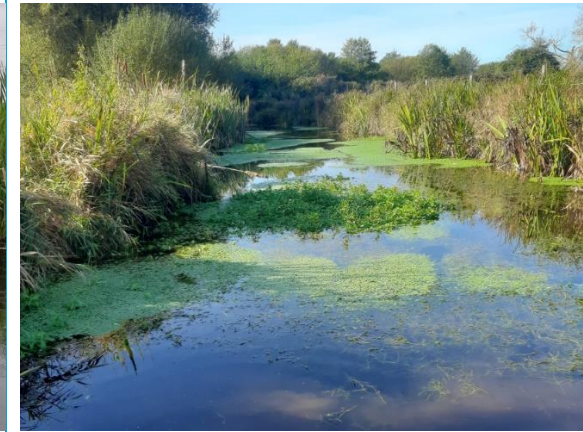
View upstream at Site 4, 12 l/s (27/10/2022)

It should be noted that downstream of Site 4, the channel changes direction and splits. There is penstock weir with wooden boards on the channel entering 'the Canal'. It is not known the extent to which the position of the boards was altered during the course of the monitoring but it is likely that any movement could have influenced the flow monitoring data.

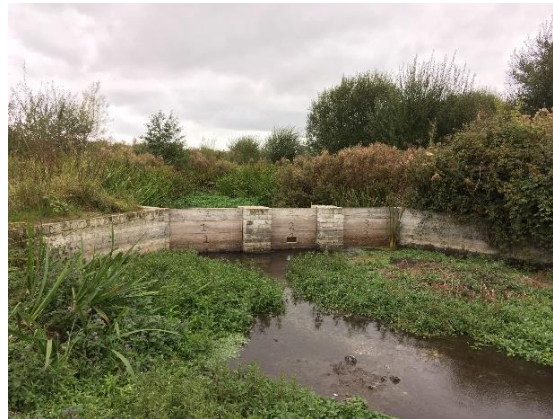
River Ems inflow into mill pond downstream of Site 4 (historical photo from 30/09/2020)

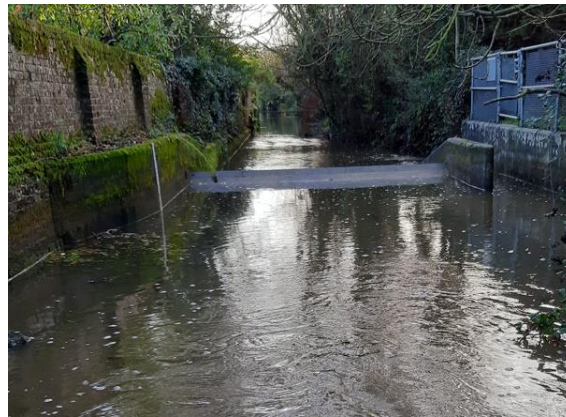
Site 7 River Ems at Westbourne Gauging Station
 Spot flow gauging was undertaken at the gauging station as part of the weekly monitoring round. Monitoring was not undertaken at this location during October to allow additional spot flow measurements to be taken in the stretch of interest upstream (at Site 3a).
 Flows recorded at Site 7 were similar to the Westbourne GS record. Some discrepancies are expected due to difficulties and inaccuracies through gauging in very low flow conditions. There will also be some differences when comparing average daily flow at the GS to instantaneous spot flow measurements.
 The highest flow measured was 122 l/s (10,540.8 m³/day on 08/11/2022) and the lowest was 15 l/s (1,206 m³/day on 28/09/2022).

View downstream at Site 7, 122 l/s (08/11/2022)

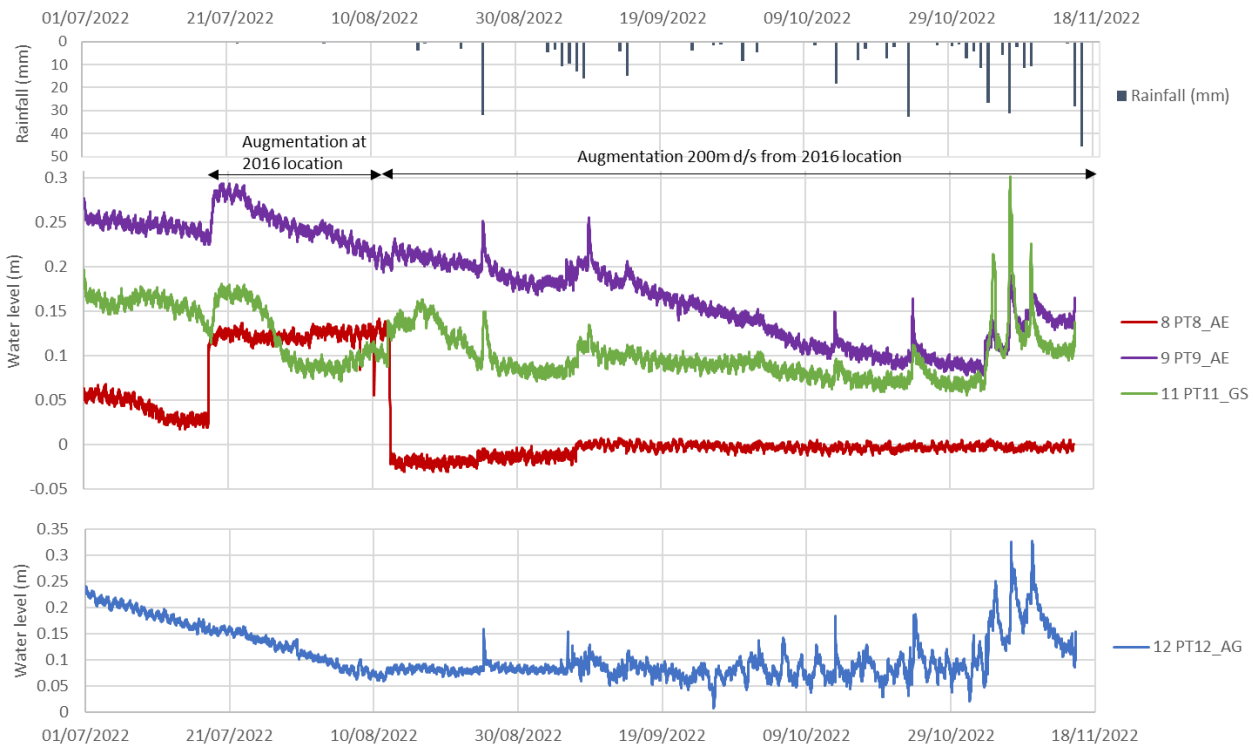
Figure 3-10 – River level logger data for the augmentation trial period

Figure 3-10 shows the river level data from the loggers over the augmentation trial period.

The data from PT 12 show the surface water levels in the Aldsworth Arm to decline over time through July and August corresponding with high temperatures, extremely low rainfall in these months and resultant ongoing drought conditions. There does appear to be a very slight increase in water levels on 12th August in response to the augmentation being moved to the trial location. The water levels at this location appear to show a clear response to rainfall.

The river level data from other monitoring installations were discussed in section 3.4.3. It was noted that PT11 (located downstream from PT 9) appeared to show the same magnitude of water level response to the augmentation start as PT 9 and a larger increase in response to the move to the trial location. Figure 4-5 shows the river level data together with groundwater level data to examine this in more detail.

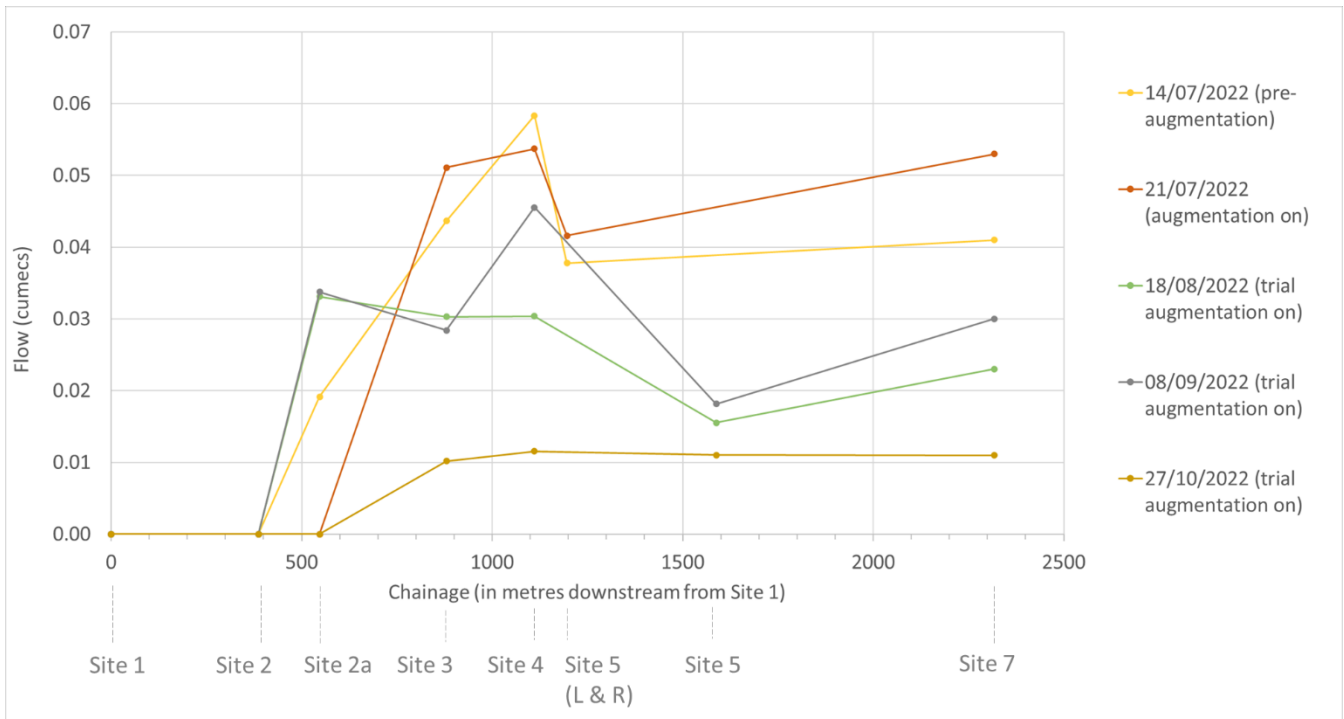
Figure 4-3 – River Ems flow accretion

In terms of flow accretion, it is worth noting the Aldsworth Arm appears to have made relatively little contribution to flow in the River Ems throughout the majority of the augmentation period. The Aldsworth Arm was observed to be dry between August and October 2022 (see Table 3-2). Although considered a significant tributary of the River Ems, this is clearly not the case during lower flow periods. Flows in the Aldsworth Arm were observed to increase rapidly in response to rainfall at the end of October, and this will have contributed to the flow peak observed at the Westbourne gauging station on the River Ems.

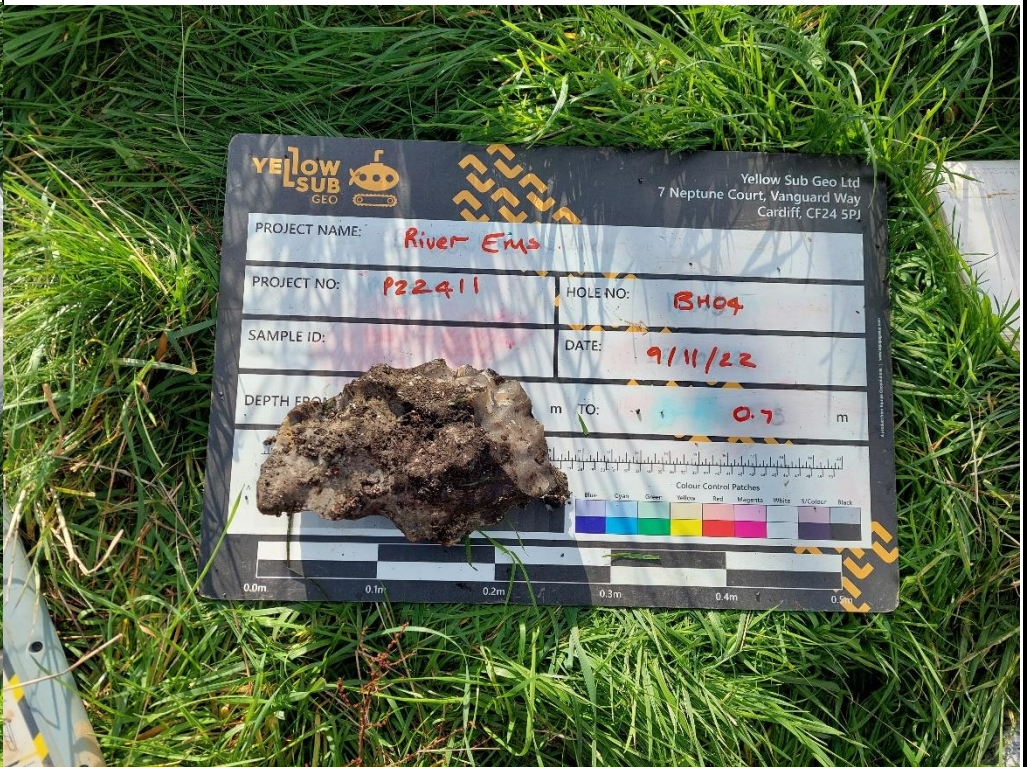
Flint cobble at 0.7m bgl within BH04

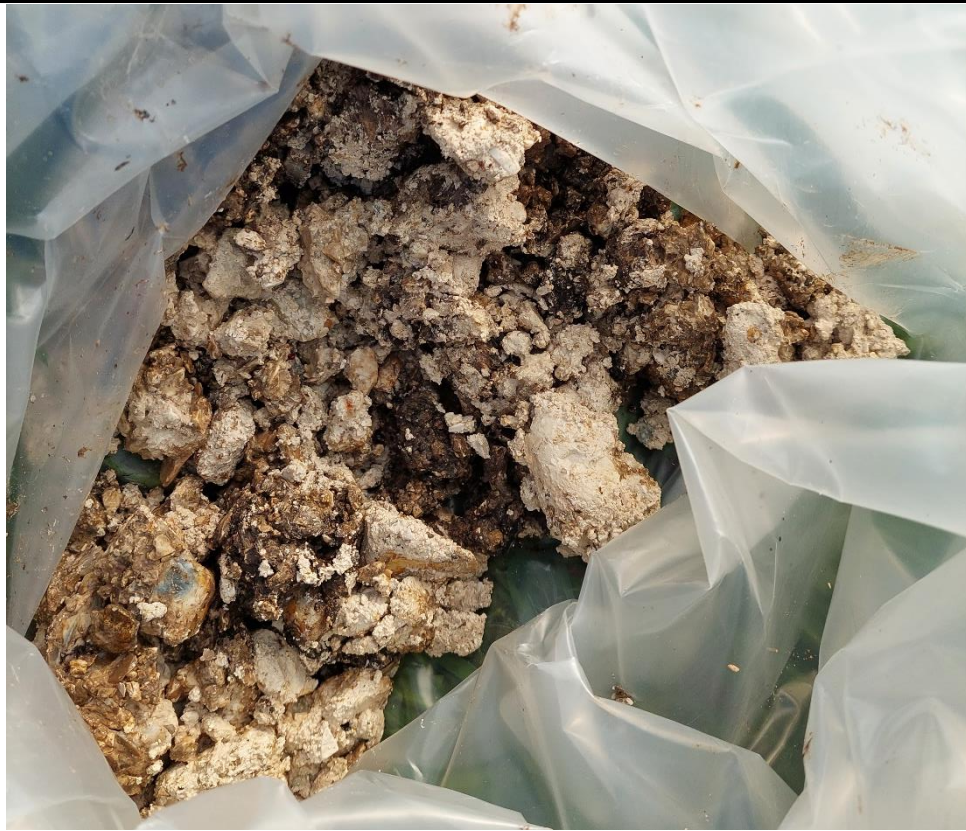
Chalk encountered at 1-1.2m bgl in BH04
